Potential Dangers of Federal Pacific Electric Stab-Lok Breakers and Panels

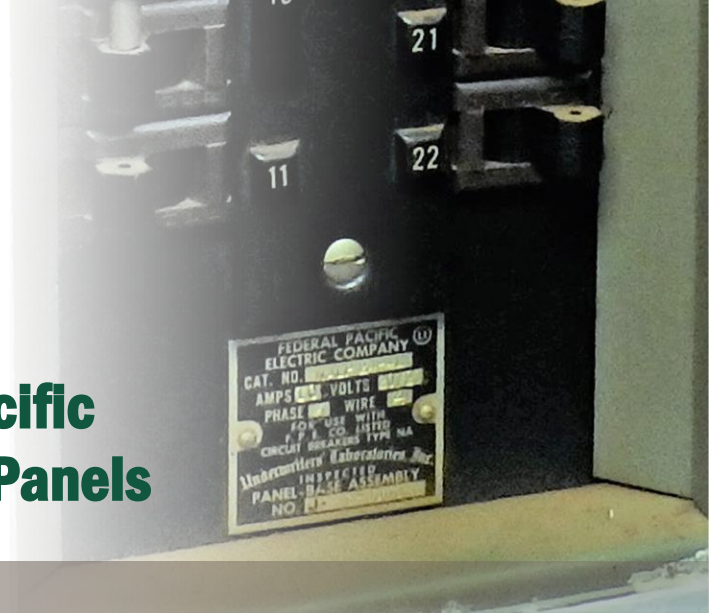
Federal Pacific Electric (FPE) Stab-Lok panels and circuit breakers were manufactured during the 1950s into the 1980s. An estimated tens of millions of FPE Stab-Lok panels were sold and can be found in service today throughout the United States and Canada in both residential and commercial settings. Jesse Aronstein, PhD, P.E. has been testing Stab-Lok breakers for decades. Aronstein testified in lawsuits against Federal Pacific Electric Company and published reports about the failures of Stab-Lok breaker panels and how they may be associated with as many as 2,800 electrical fires each year in the United States.¹

FPE panels reportedly have a higher rate of failure than current UL listed service panels. The primary concern is that when there is an electrical surge, or branch circuit overload, the circuit breakers may not trip, or close the circuit. Should a circuit breaker fail to trip under these conditions, a continuous electrical supply continues to flow potentially creating ‘hot spots’ that are often concealed behind combustible walls. When this occurs, the building is at a high risk of igniting combustible structural members, and ultimately a destructive fire. When a circuit breaker fails to trip the circuit, a high degree of personal danger also exists and may result in electrical shock and electrocution.

Aronstein reported Stab-Lok panels sustained a ‘high defect rate’ and advised to have them replaced. A best practice is to hire a licensed, certified and insured electrical contractor to remove all FPE electrical service panels and their Stab-Lok circuit breakers, and to replace them with industry suitable circuit breaker panel boards to reduce the potential for electrical fires and injury. For more information regarding FPE Stab-Lok breaker panels, please contact Acadia’s Virtual Loss Control team at virtualc@acadia-ins.com or 207-874-5701.
